Waterworks District 9, Ward 4 Meeting Minutes Regular Board Meeting Monday, May 8, 2023 5:30 pm – Conference Room

Engineer's Report for May 8, 2023, Board Meeting

LEI Project No. 19-007 Water Storage Tanks Rehabilitation

Town of Carlyss Ground Storage Tanks

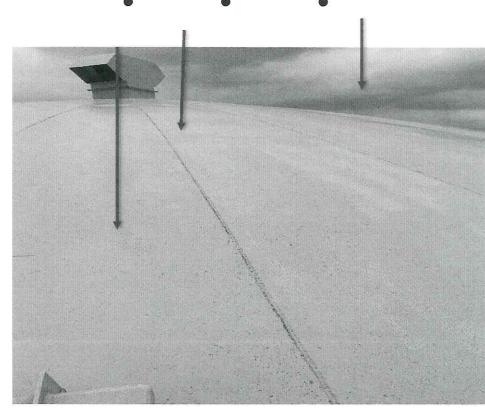
Tank Roof

- South Tank was blasted and repainted in November 2000
- delamination and spot corrosion beneath the The existing coating was exhibiting various types of failure including cracking, coating
- These issues combined with the age of the coating, make overcoating this tank risky

- Areas where the clear coat has worn away
- These would be areas that would be touched up
- Represents approximately 15-25% of the surface area

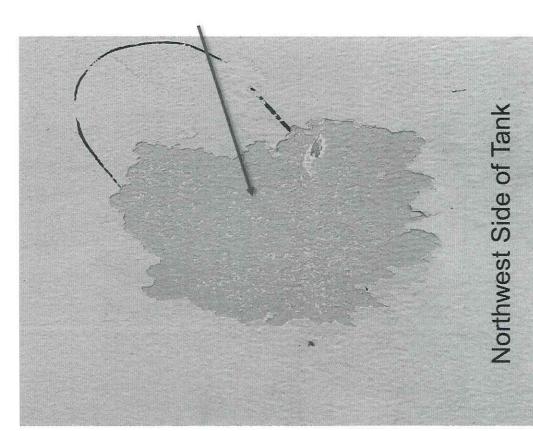
- North Tank was built in June 2000
- It is believed to have been overcoated sometime between then and now.
- The existing coatings are exhibiting poor adhesion in a number of areas
- film thickness make overcoating this tank risky The poor adhesion combined with the higher

- Water blasted area
- Most recently applied overcoat system is poorly bonded to original coating
- appears to be experiencing the The Northwest side of the tank worst adhesion

The variation in adhesion combined with the higher film thickness makes overcoating this tank riskier than I had originally believed. As such, I would recommend the exterior be blasted and repainted.

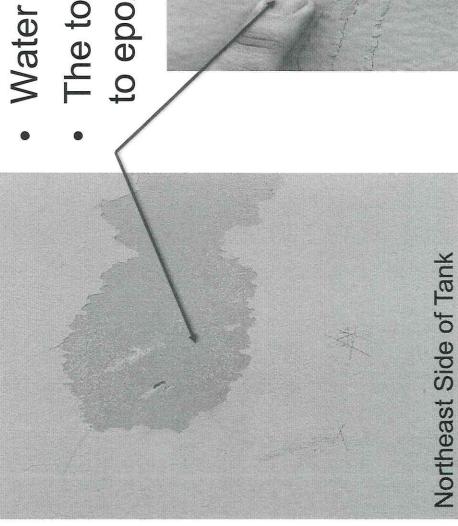
Water blasted area

The topcoat is poorly bonded to epoxy intermediate coat

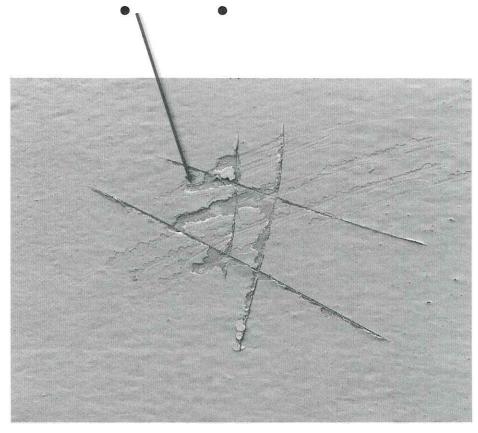
East Side of Tank

This area was not water blasted

Although adhesion is better on the east side of the tank; it is still poor in many locations

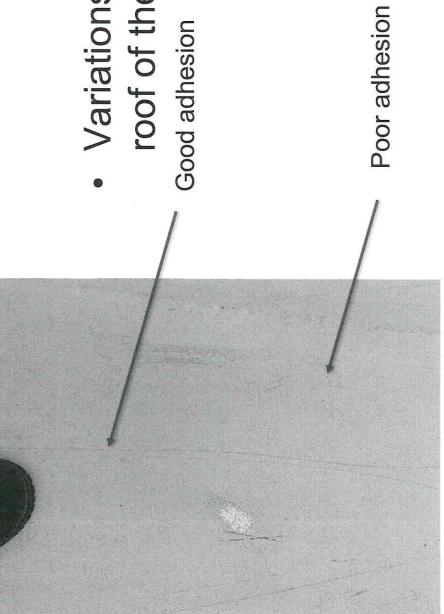
Tank Roof

Variations in adhesion on the roof of the tank

Good adhesion
